Background

A petrochemical plant in southern Taiwan was shut down at the end of 2015. AECOM carried out detailed soil and groundwater assessment and high concentrations of Total Petroleum Hydrocarbons (TPH) were found, mainly originating from base oil, lubricants and process byproducts. Site remediation activities officially started on 1st January, 2017. Around 14 hectares of land requires remediation over a 3-4 year period

Rapid Measurement of Petroleum Hydrocarbons during Site Remediation

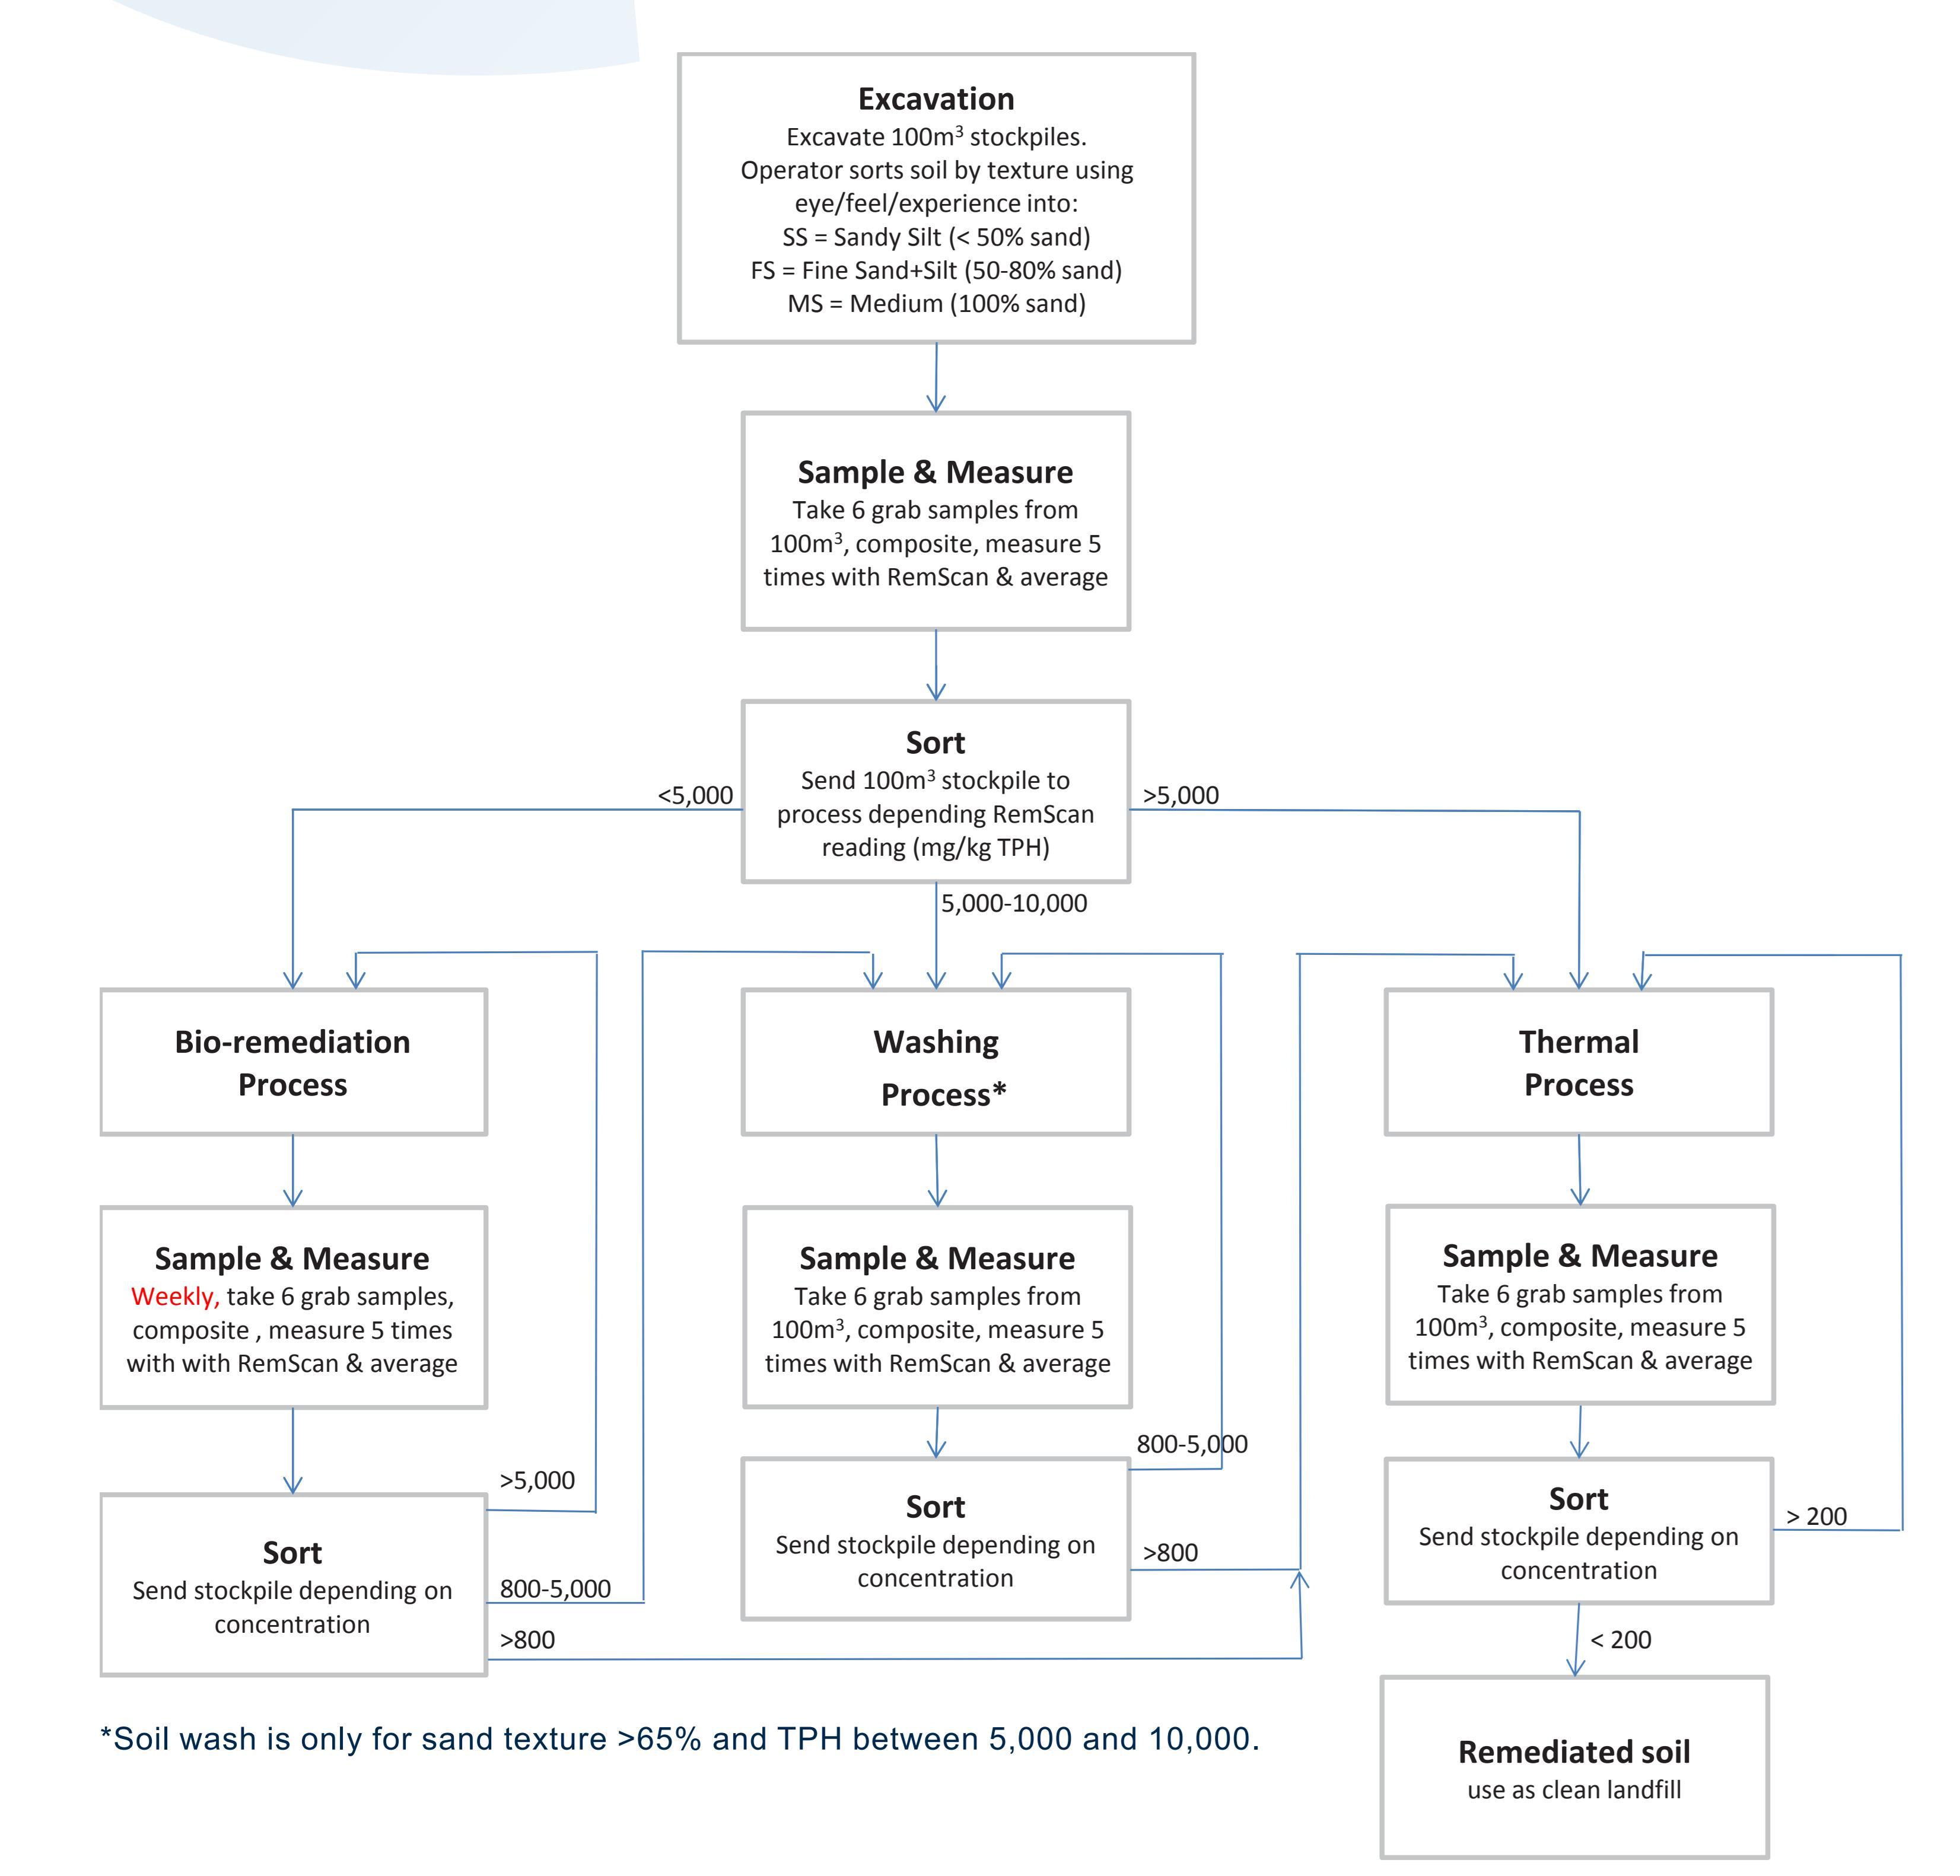
Figure 1: Remediation Process Flow Chart

A handheld infrared instrument for the rapid measurement of TPH in soil (RemScan[®]) is being employed as a screening tool to help classify and segregate soils for the different remediation methods. The process flow chart is shown in Figure 1 including how RemScan is used.

According to the results of the site investigation, the remediation plan for the site will use a combination of biological treatment, soil washing, and thermal treatment. All of the contaminated soil will be excavated (down to several metres in some areas), and the appropriate remediation method will be chosen based on soil texture, contaminant levels and regulatory targets.

Biological treatment will be used for low TPH concentration soil. Soil washing and thermal treatment will used for higher TPH concentration soil with sandy or silty textures, respectively.

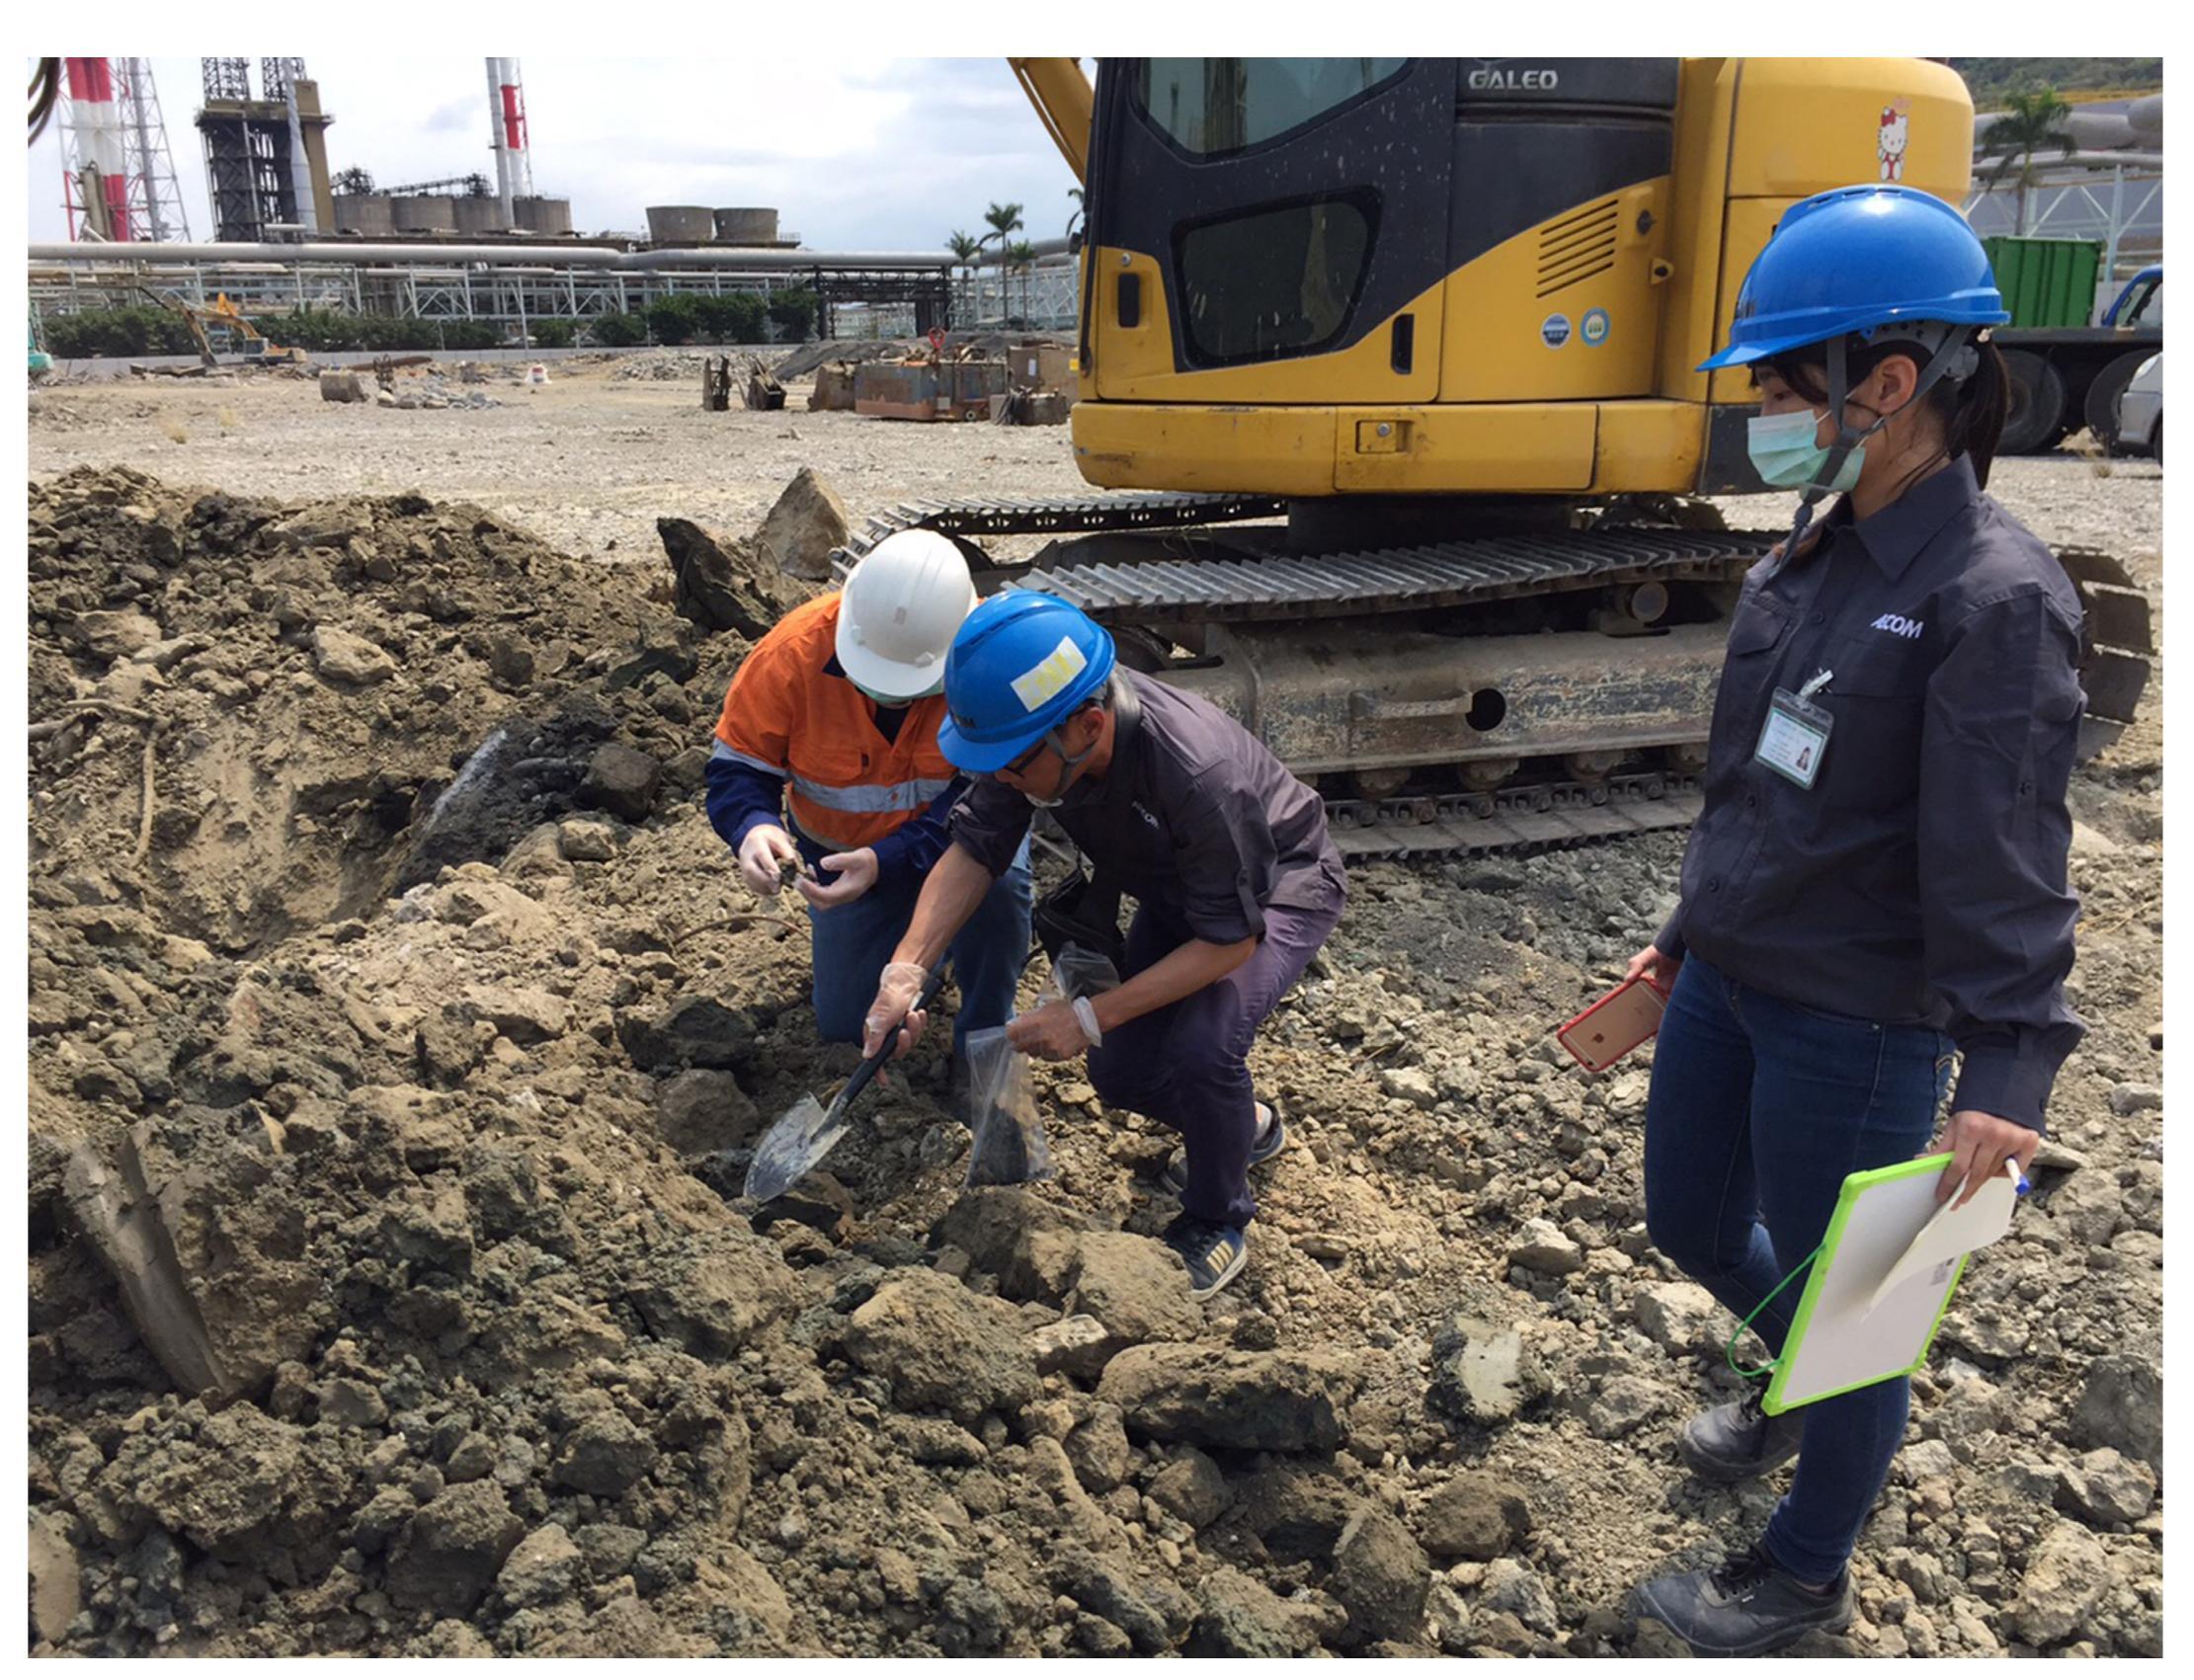
Figure 2: In-field sampling prior to measurement with RemScan

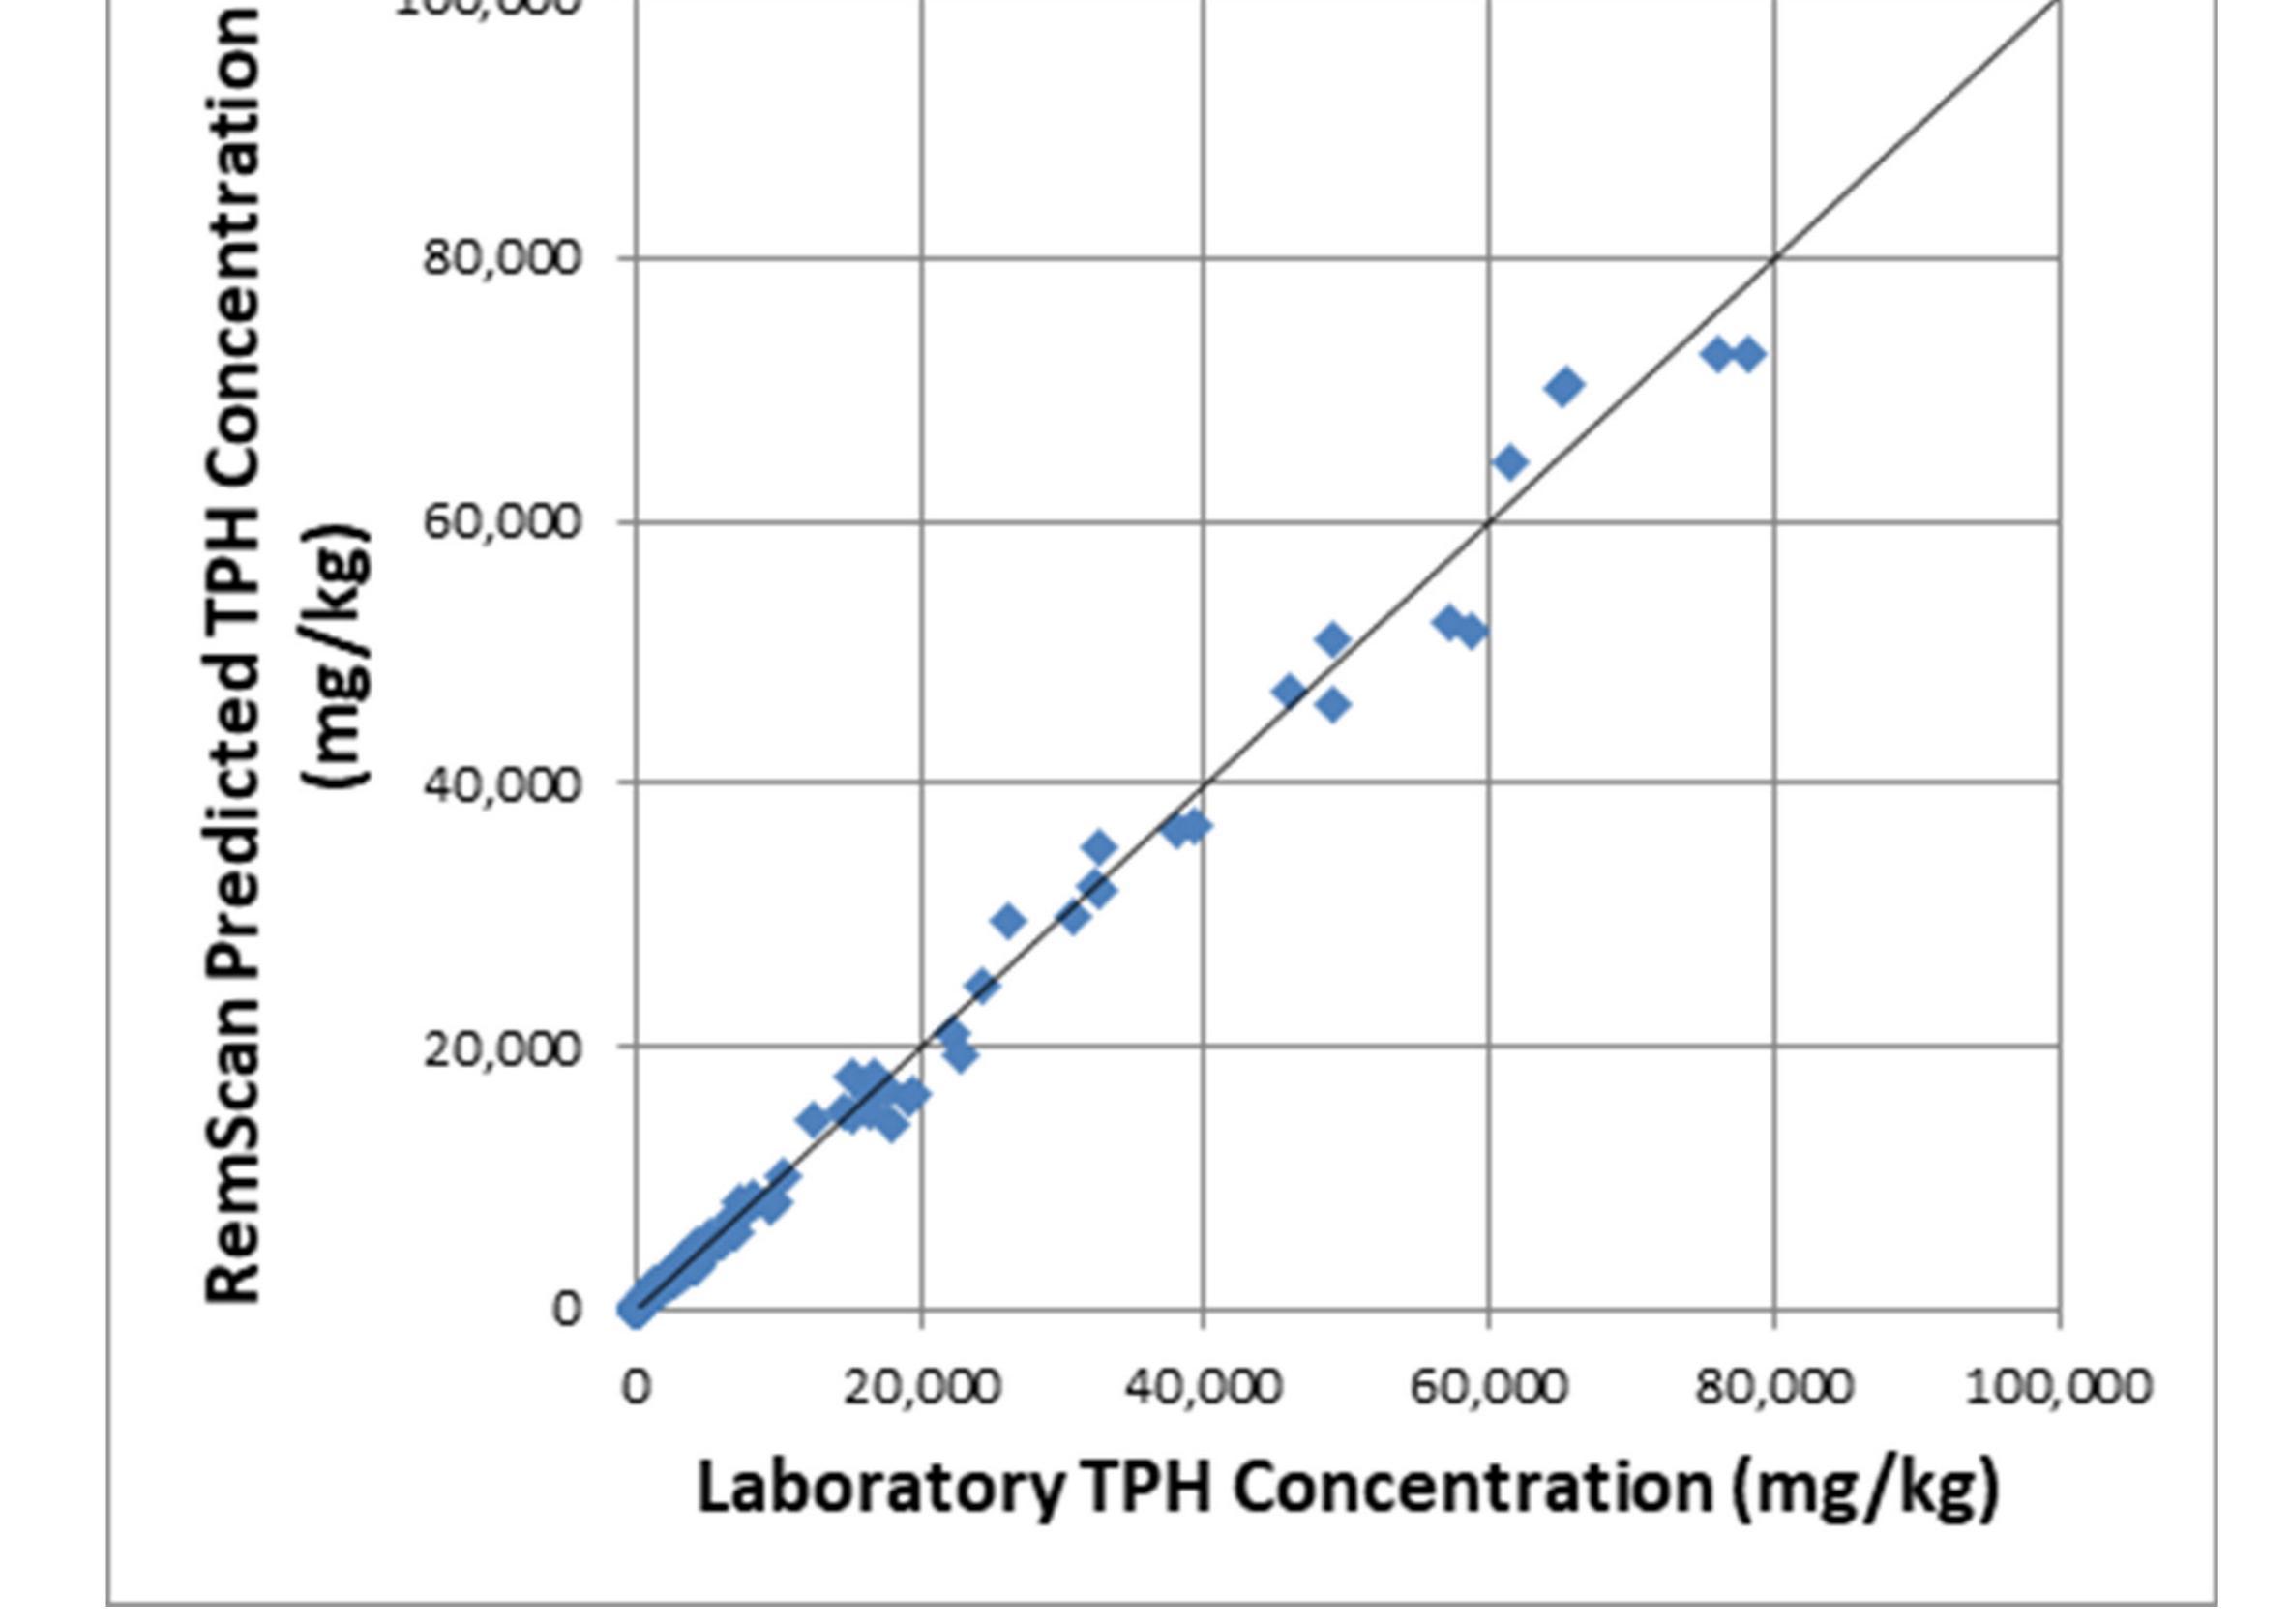
The handheld infrared instrument was calibrated using representative soils from the remediation site. The instrument was then validated by scanning selected soils and then sending the scanned soils to an external laboratory for TPH $(C_{10} \text{ to } C_{36})$ analysis using US EPA Method 3570:8015C. The result of the calibration modelling is shown in Figure 3. The tight clustering of points about the Y=X line demonstrates RemScan's high level of accuracy for this application.

RemScan versus Laboratory TPH Measurement

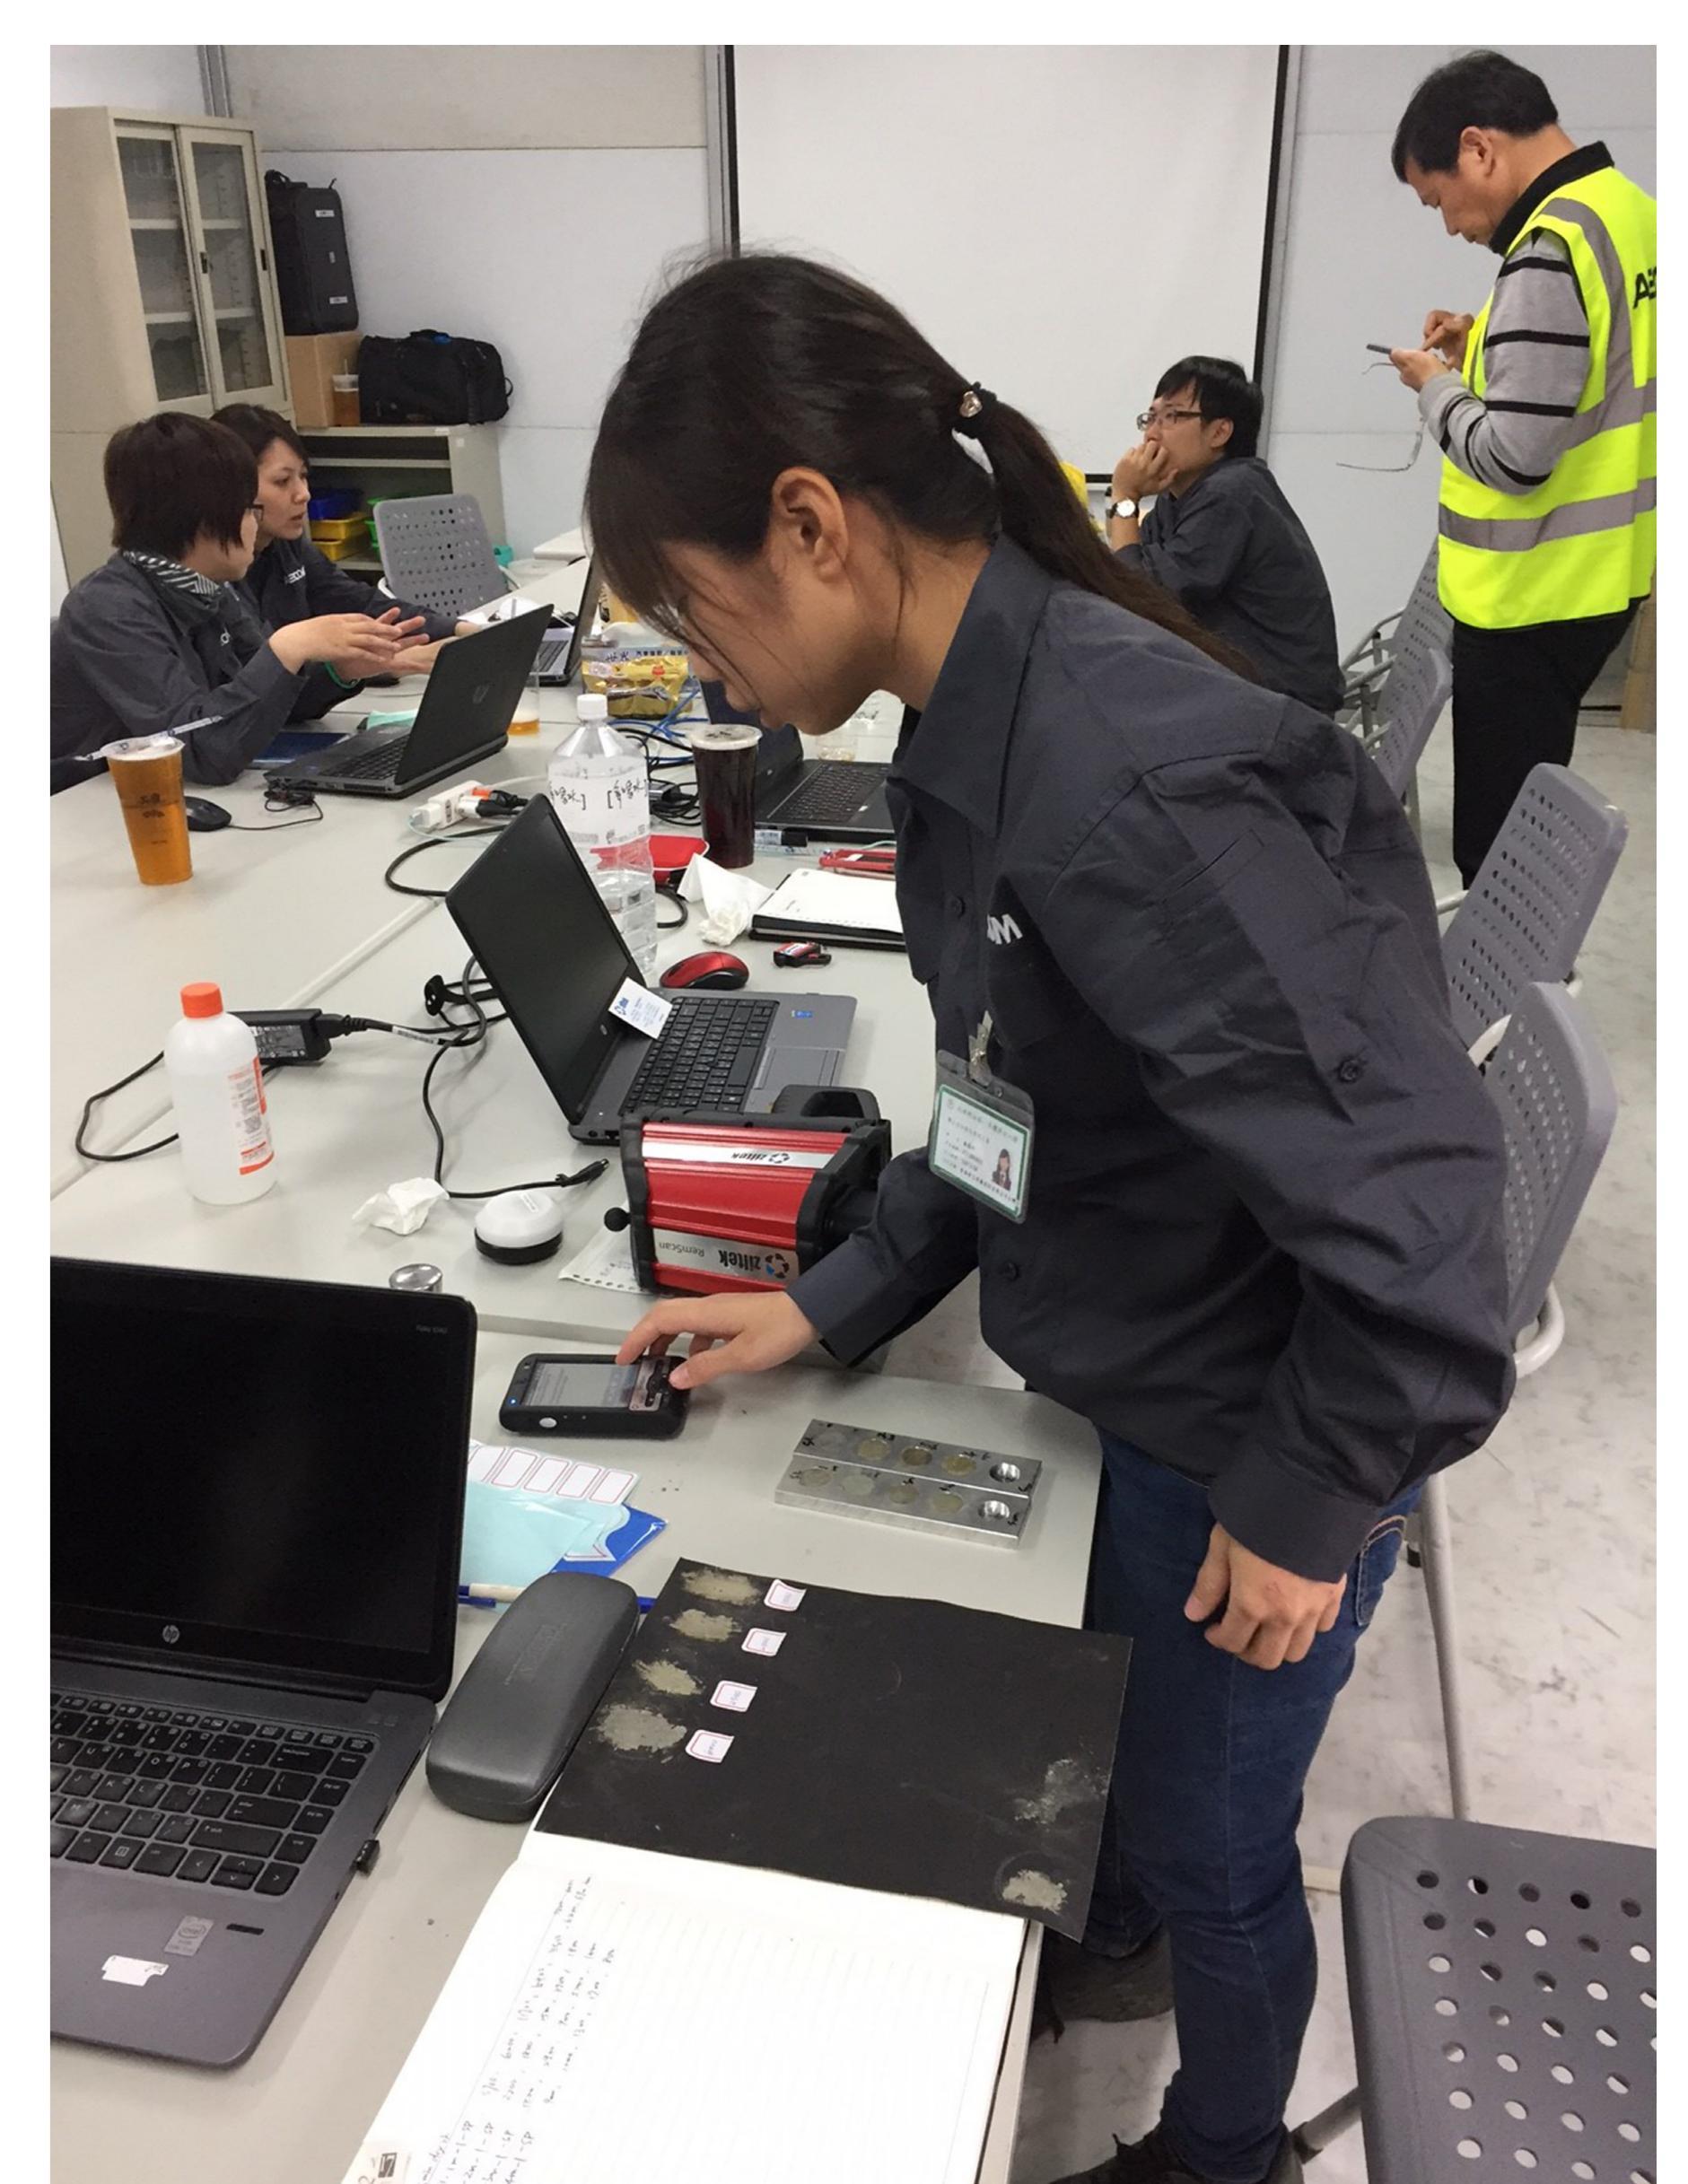
Figure 4: Measuring samples with RemScan after drying
