# CASE STUDY

## RemScan Used in Rapid Response to Diesel Spill

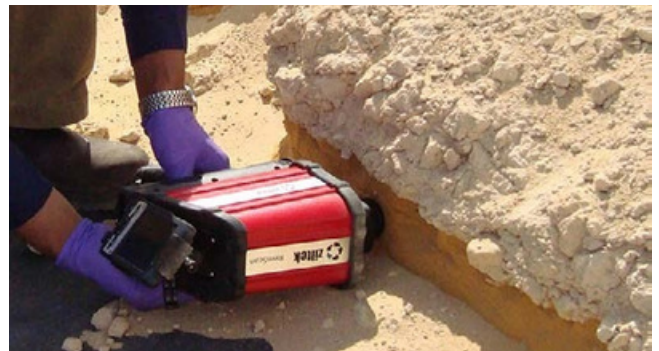
Comparison of RemScan data to lab data for TPH (C<sub>10</sub> - C<sub>36</sub>)

To independently verify the instrument's performance, 19 'blind' soil samples were sent to a NATA-accredited laboratory for analysis. A very close correlation was observed between the TPH values predicted by RemScan and the laboratory data with an R<sup>2</sup> value of 0.997.
