RemScan used in Rapid Response to Diesel Spill

A significant amount of diesel leaked from a storage facility in Western Australia and was captured in an emergency bund area.

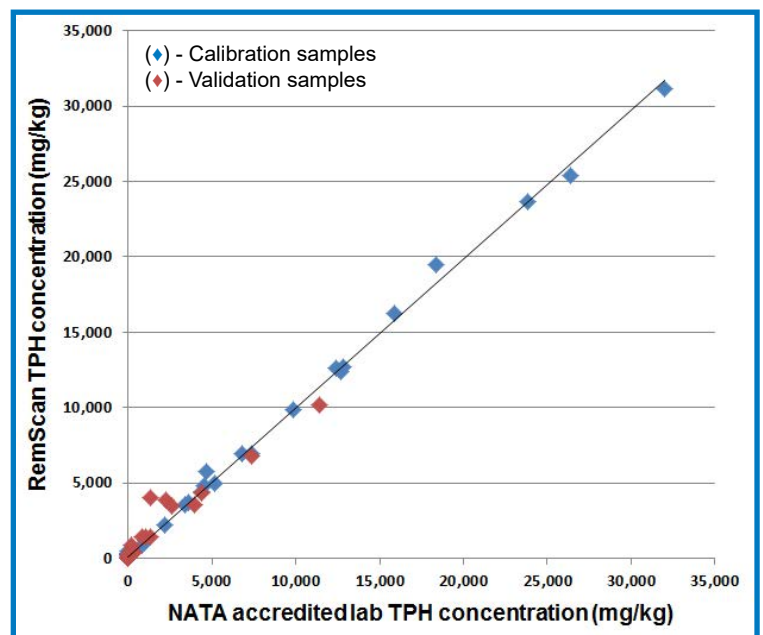
Comparison of RemScan data to lab data for TPH (C₁₀ - C₃₆)

To independently verify the instrument's performance, 19 'blind' soil samples were sent to a NATA-accredited laboratory for analysis. A very close correlation was observed between the TPH values predicted by RemScan and the laboratory data with an R² value of 0.997.
